Intake Hose Collapse

Models:

02/2022 > FJA300

F33a-FTV

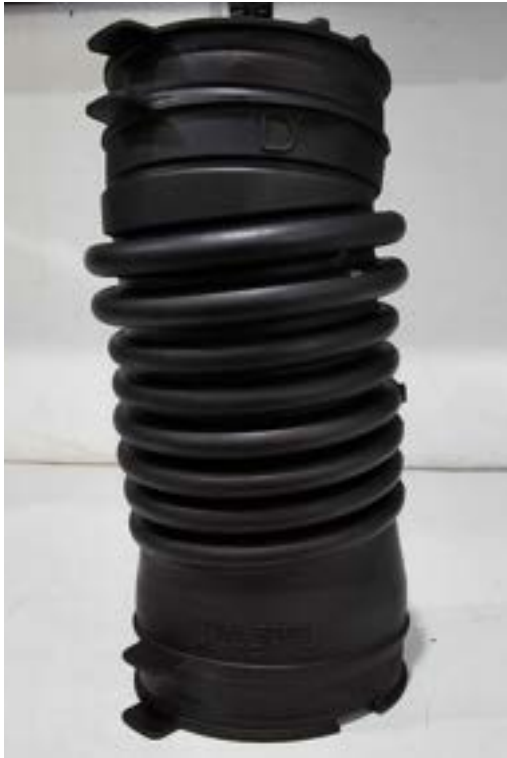
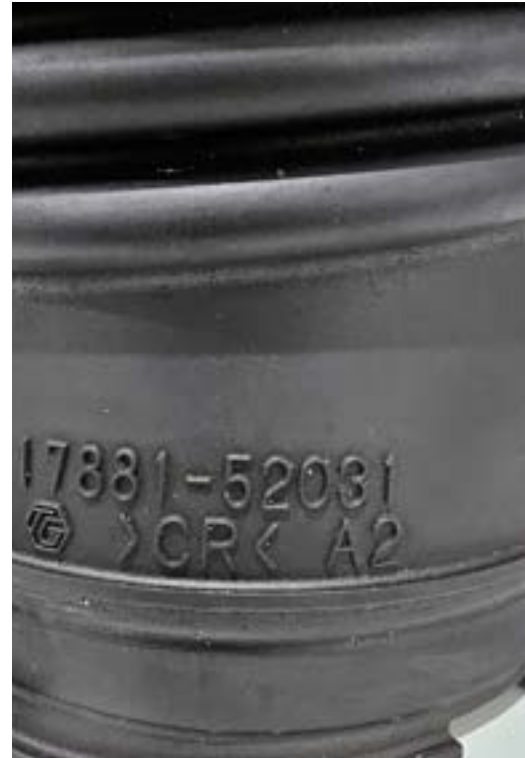
**Affected
Component
Image:**

During heavy acceleration or engine load, customer may experience sensation of loss in power with lack of acceleration or speed. No DTC's may occur.

Access engine bay, apply firm pressure to the centre of the intake pipe between air box and engine assembly. If hose is found to have reduced structural integrity inspection of part number is required.

Model	Engine	Previous Part NO.	Affected Part NO.	Part Name	QTY
Landcruiser FJA300	F33a-FTV	17881-52030	17881-52031	Intake Hose	1

Trialing numerous different work arounds for the concern. Just Autos is working towards a solution for this concern in first quarter of 2024.
