Intake Hose Collapse

Models:

02/2022 > FJA300

F33a-FTV

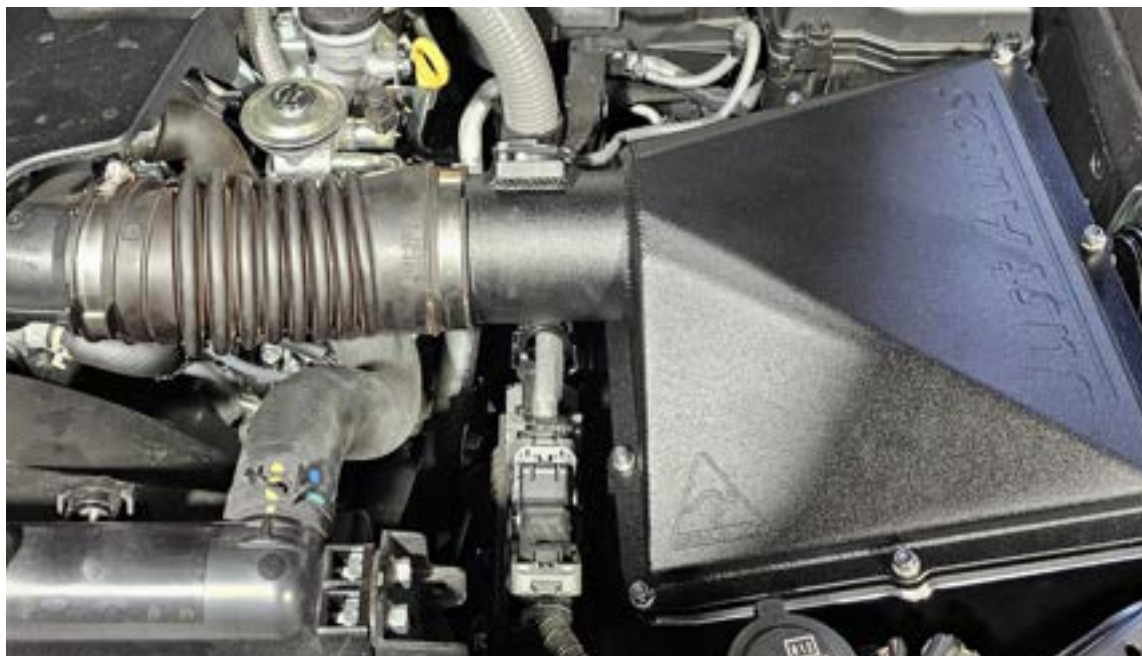
Trialing numerous different work arounds for the concern. Just Autos is working towards a solution for this concern in first quarter of 2024.

Field Fix Update 12/12/2023:

[Click Here for Field Fix](#)
